WEGA™ Direct View Television

AA-2W Chassis

Circuit Description and Troubleshooting

Course: CTV-26

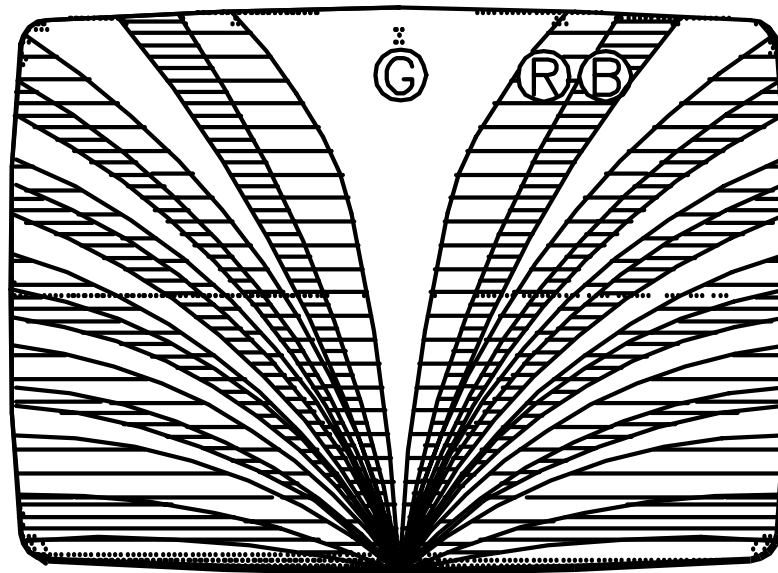
RGB RAINBOW (UNREPAIRABLE)

Below is an excerpt from the CTV-25 course. It shows several picture tube defect symptoms, some of which can be repaired without changing the tube.

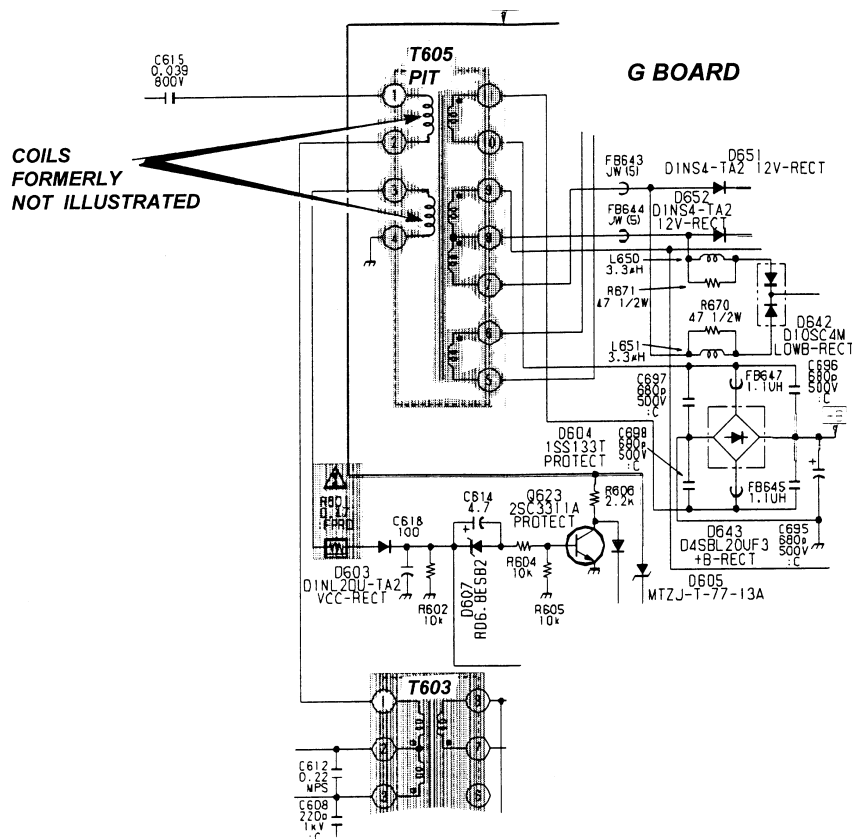
Subject: G Board Schematic Correction

On the G Board Schematic the winding connections inside T605 is incorrect. The windings between T605/pins 1 & 2, and windings 3 & 4 are missing.

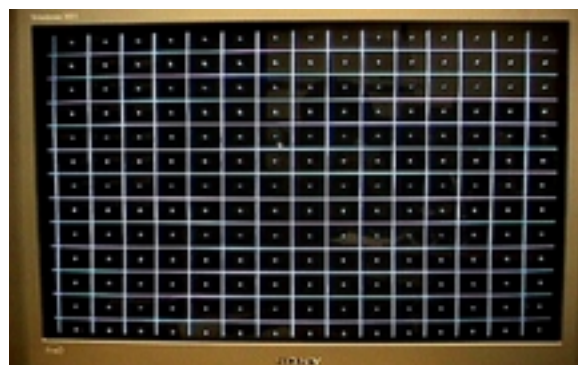
Fig. 1. Before

V-Bow Geometry distortion; like the picture in Fig 1 can be readjusted by using the Y-Magnets. The Y-Magnet is located on the Neck Assembly CRT side See Fig 3.

Adjust the taps simultaneously to achieve the best geometry. After adjusting this magnet, please confirm the geometry over all geometry again. (V-Trap, etc could also affect the geometry as well.)

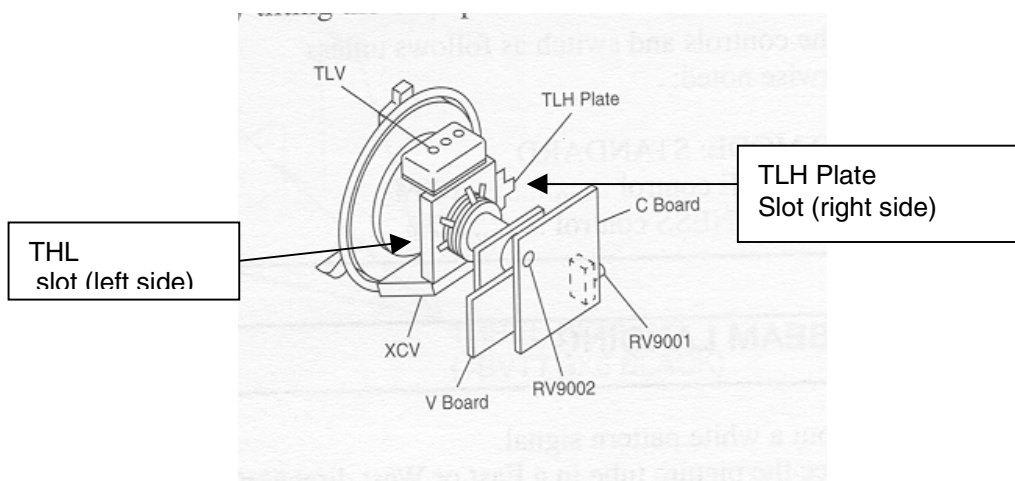
If a yoke needs replacement, the TLH plate should be removed from the old yoke, and inserted into the new yoke. If the TLH Plate was lost or misplaced the TLH plate part number is listed below.

The TLH plate can be inserted into either the left or right side of the Yoke. There is only one plate; therefore during alignment the plate must be tried in both sides of the Yoke to determine the most effective adjustment position.

The alignment procedure for the Yoke replacement can be found in Service Bulletin 387R2
